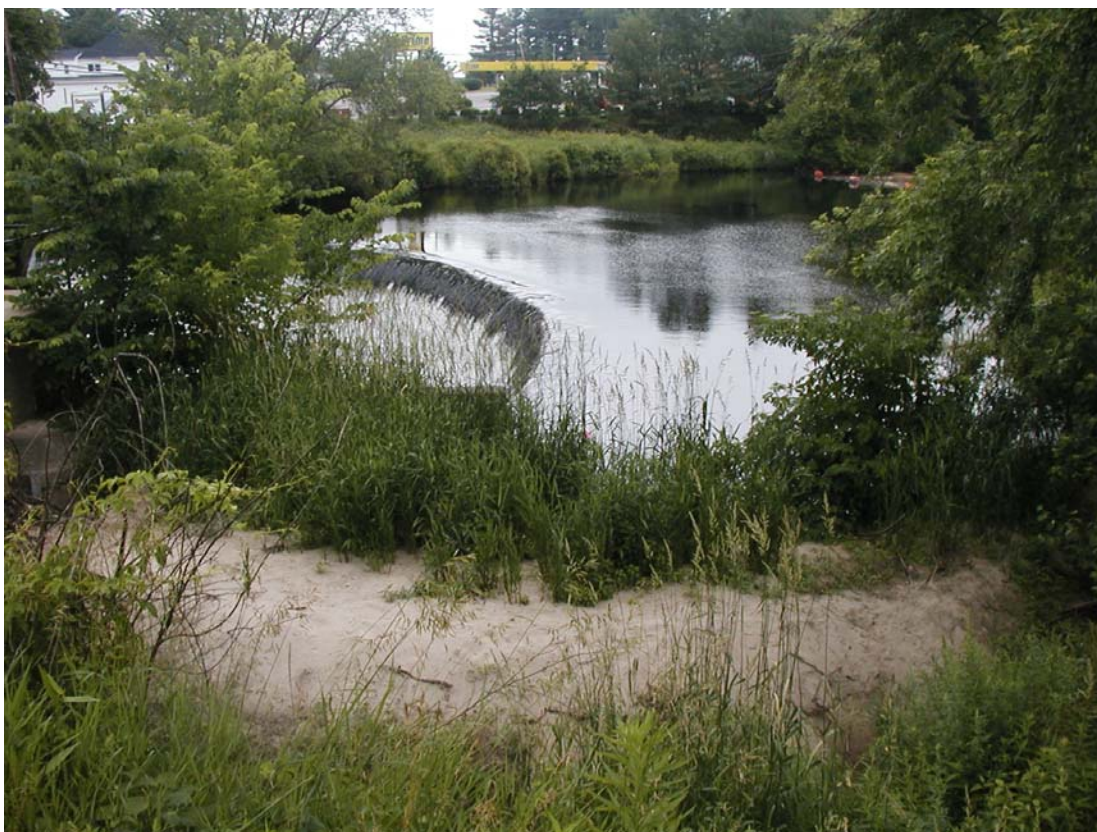
Photo No.: 1, Date: 6/25/04, Courtesy Smart Associates

Description: A significant amount of sediments have been deposited near the canal entrance.

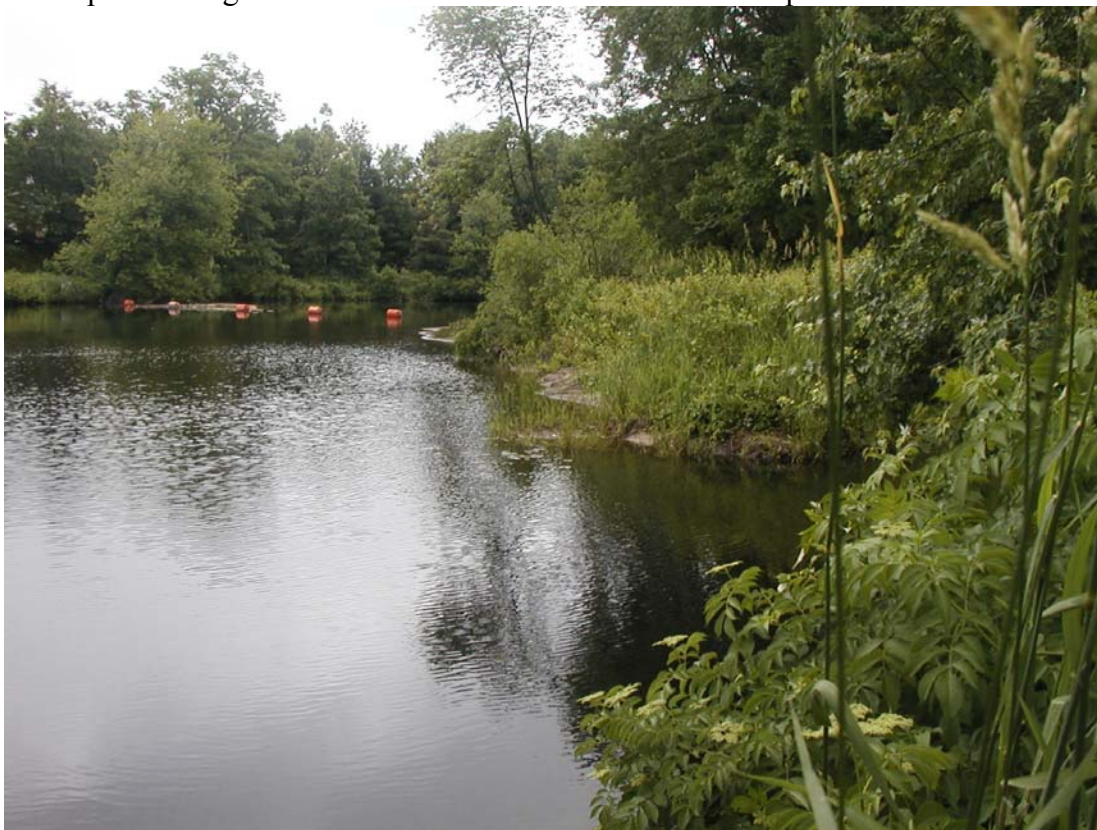
Photo No.: 2, Date: 6/25/04, Courtesy Smart Associates

Description: View of the mouth of the large impounded wetland to the right, looking upstream along the Souhegan.

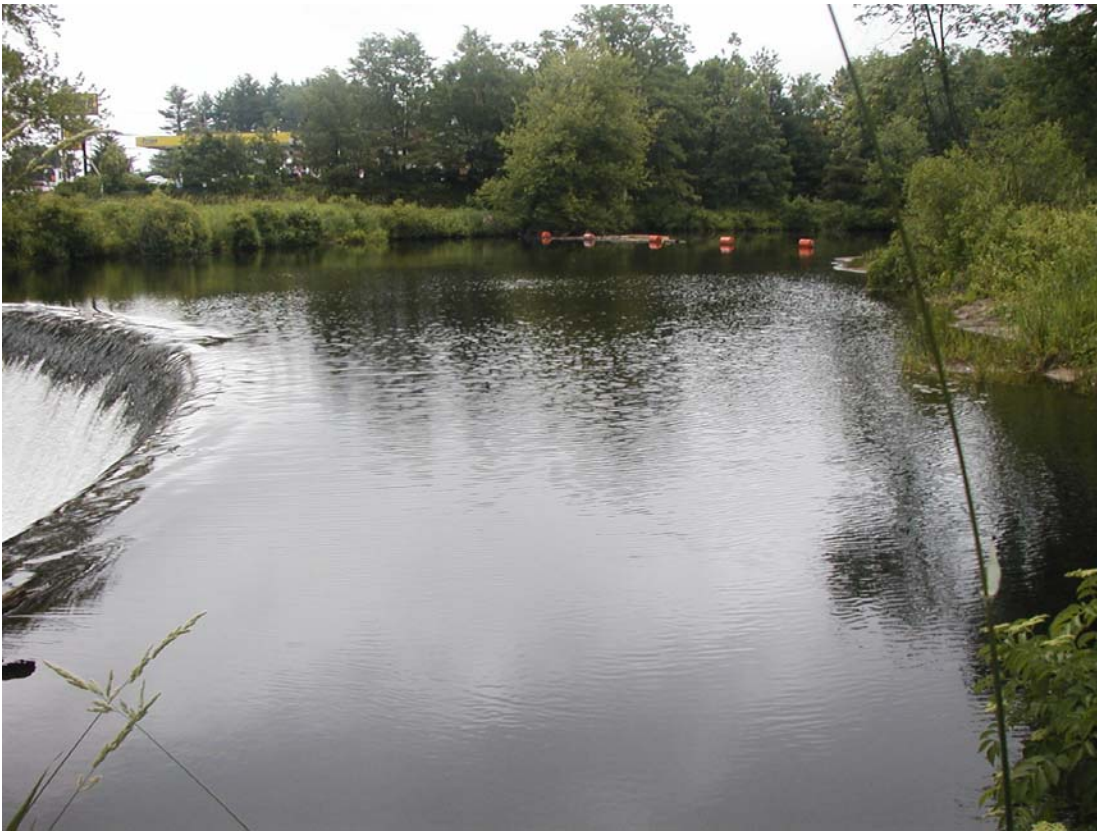
Photo No.:3, Date: 6/25/04, Courtesy Smart Associates

Description: Facing upstream, large impounded wetland to the right.

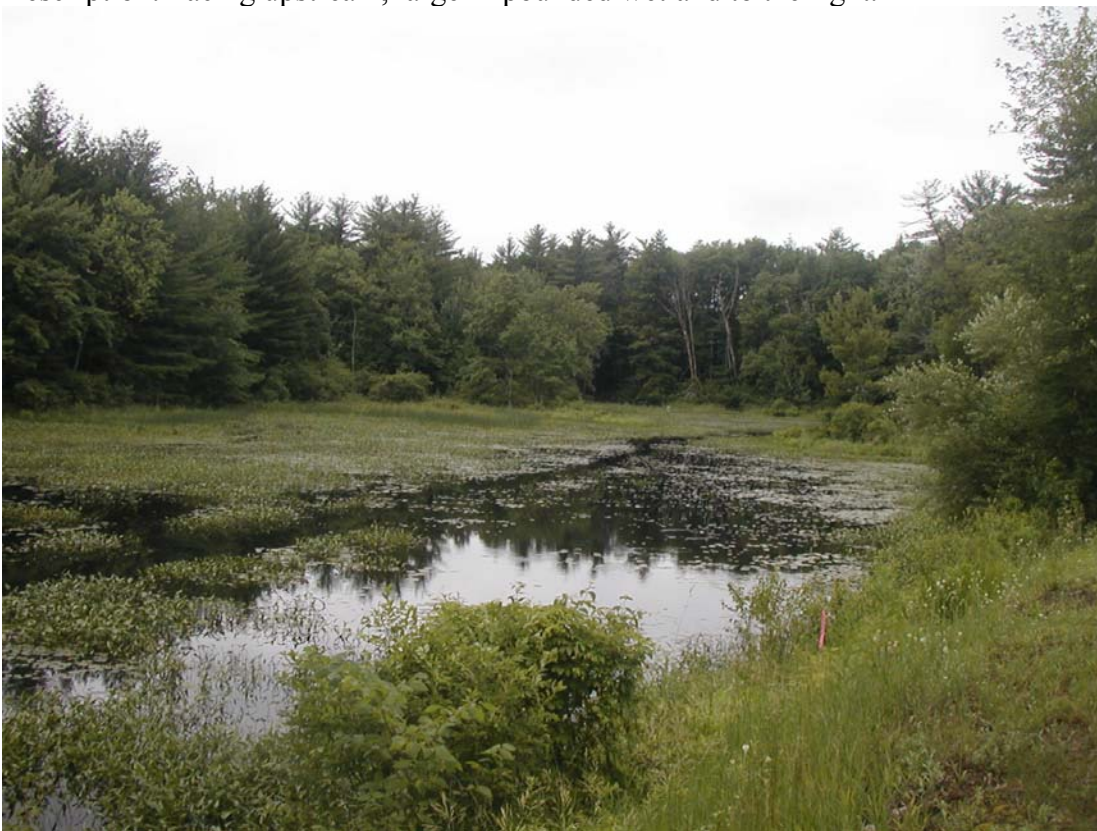
Photo No.:4, Date: 6/25/04, Courtesy Smart Associates

Description: View of the large Palustrine Open Water (POW) wetland behind the Merrimack Fire Station.

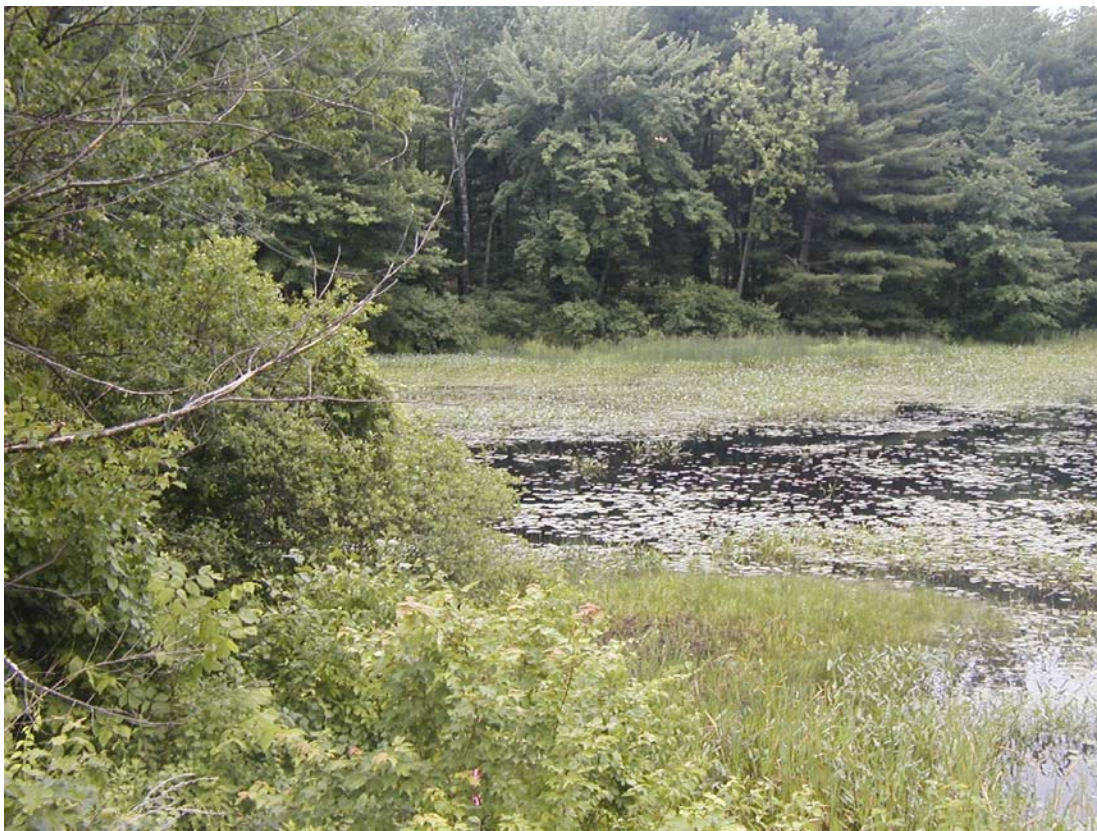
Photo No.:5, Date: 6/25/04, Courtesy Smart Associates

Description: The impounded wetland has primarily aquatic and emergent vegetation, with some wetland shrubs along the edges.

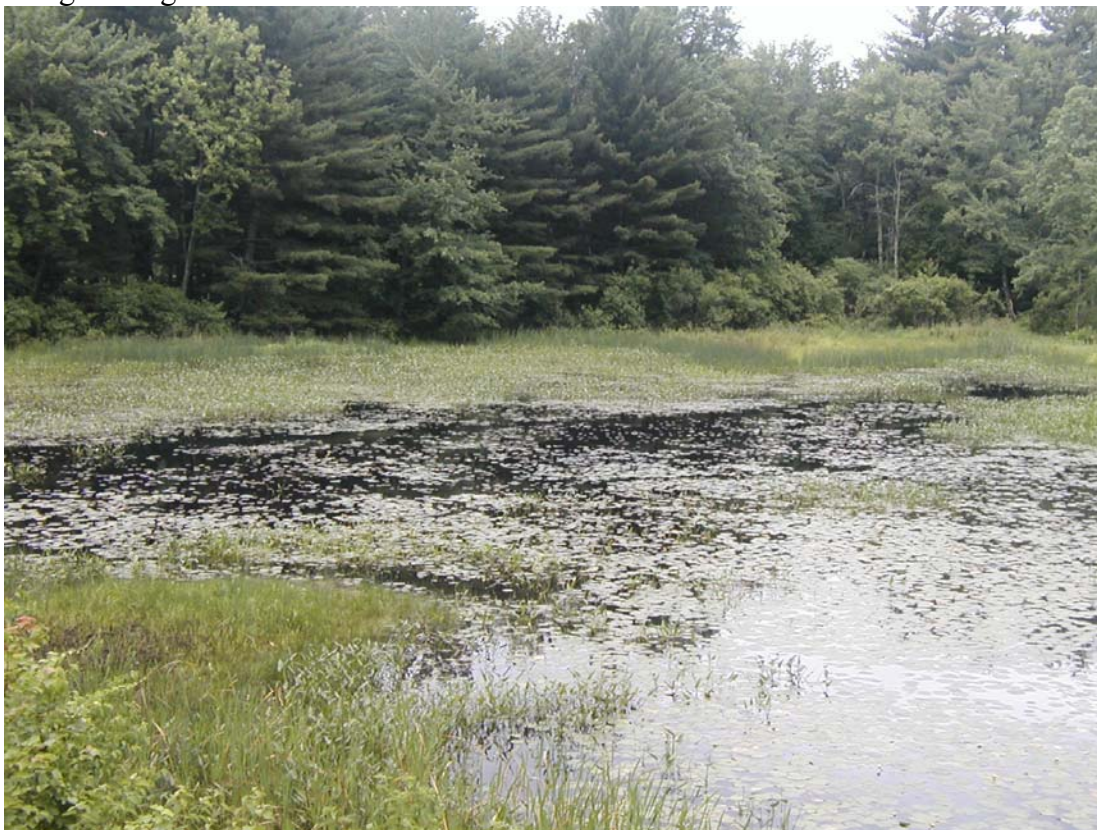
Photo No.:6, Date: 6/25/04, Courtesy Smart Associates

Description: The large white pines in the background mark the wetland/upland edge.

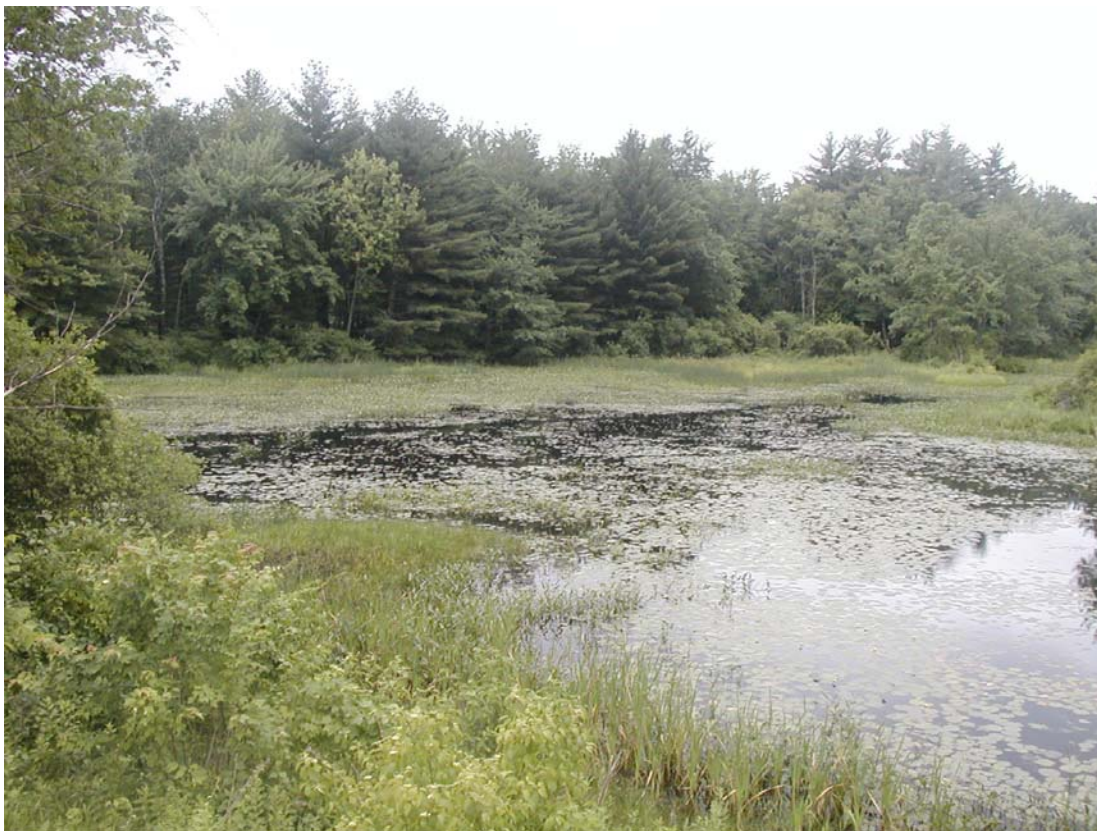
Photo No.:7, Date: 6/25/04, Courtesy Smart Associates

Description: A small intermittent brook enters the wetland on the right side of this photo.

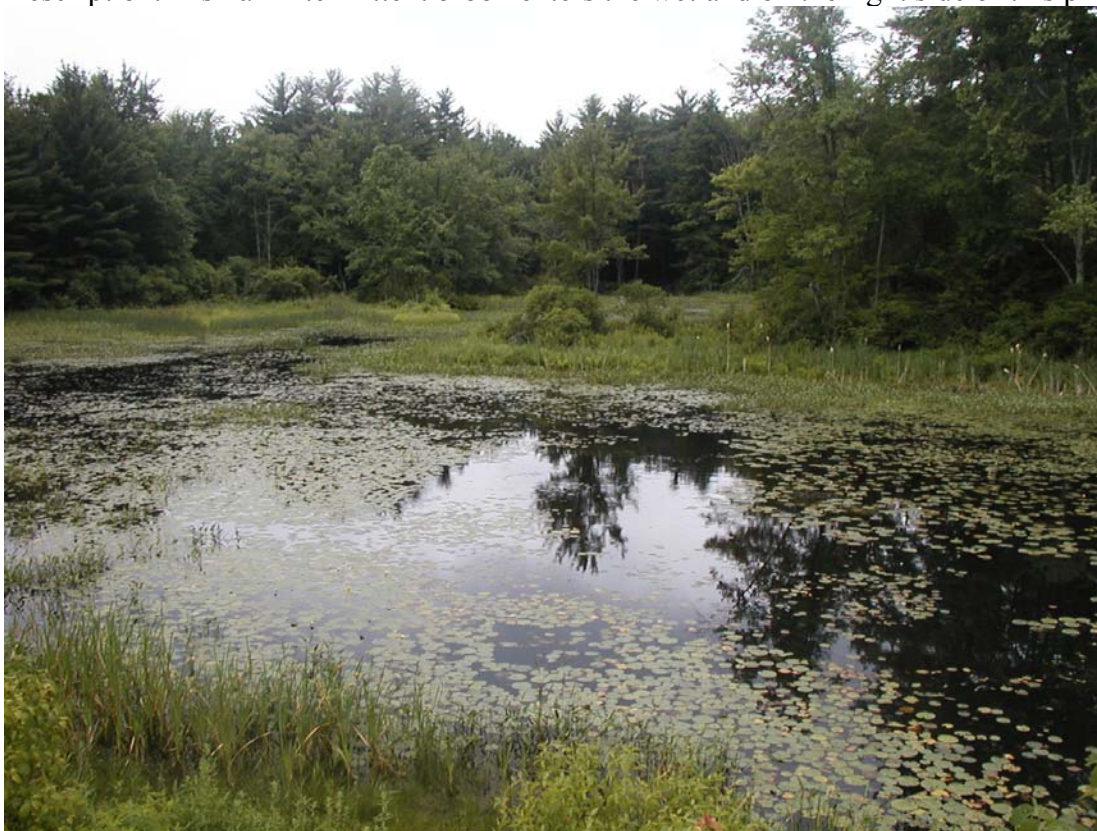
Photo No.:8, Date: 6/25/04, Courtesy Smart Associates

Description: Many sections of this wetland are dominated by water lilies (*Nuphar sp.*)

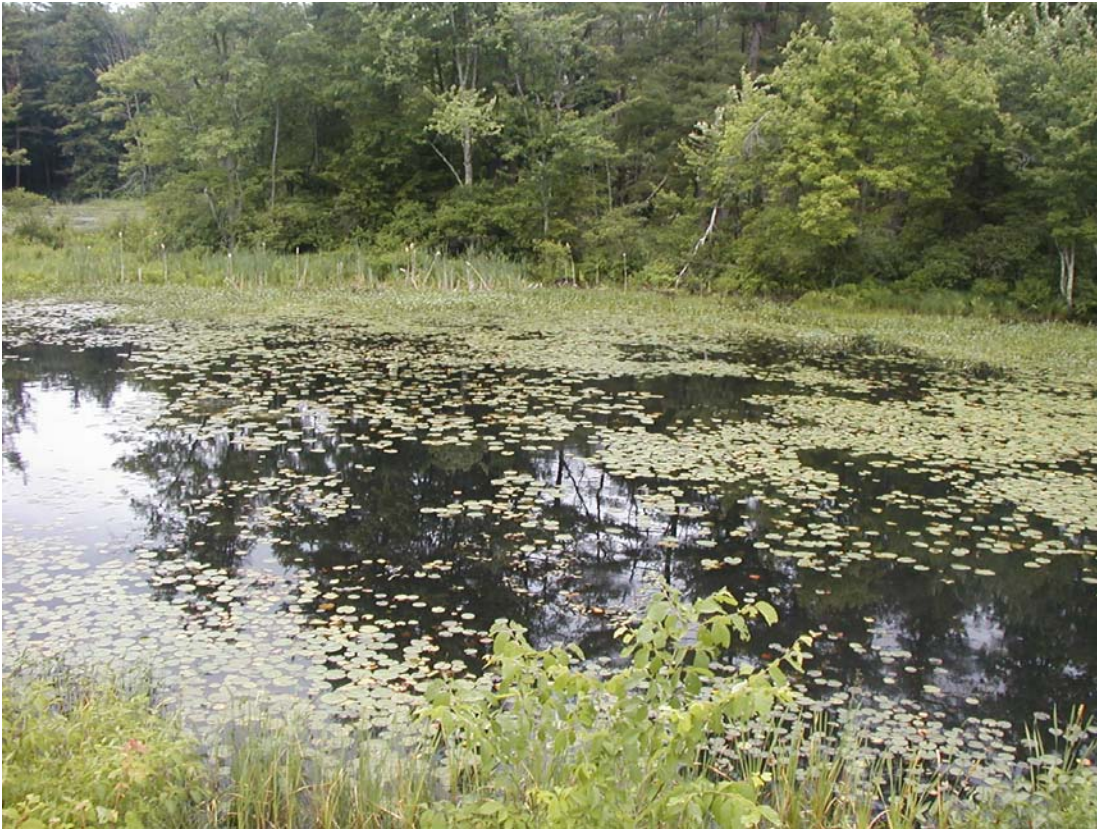
Photo No.:9, Date: 6/25/04, Courtesy Smart Associates

Description: A small island of uplands is located towards the westerly edge of the wetland. There is an area of Palustrine Forested (PFO) wetland located behind this island.

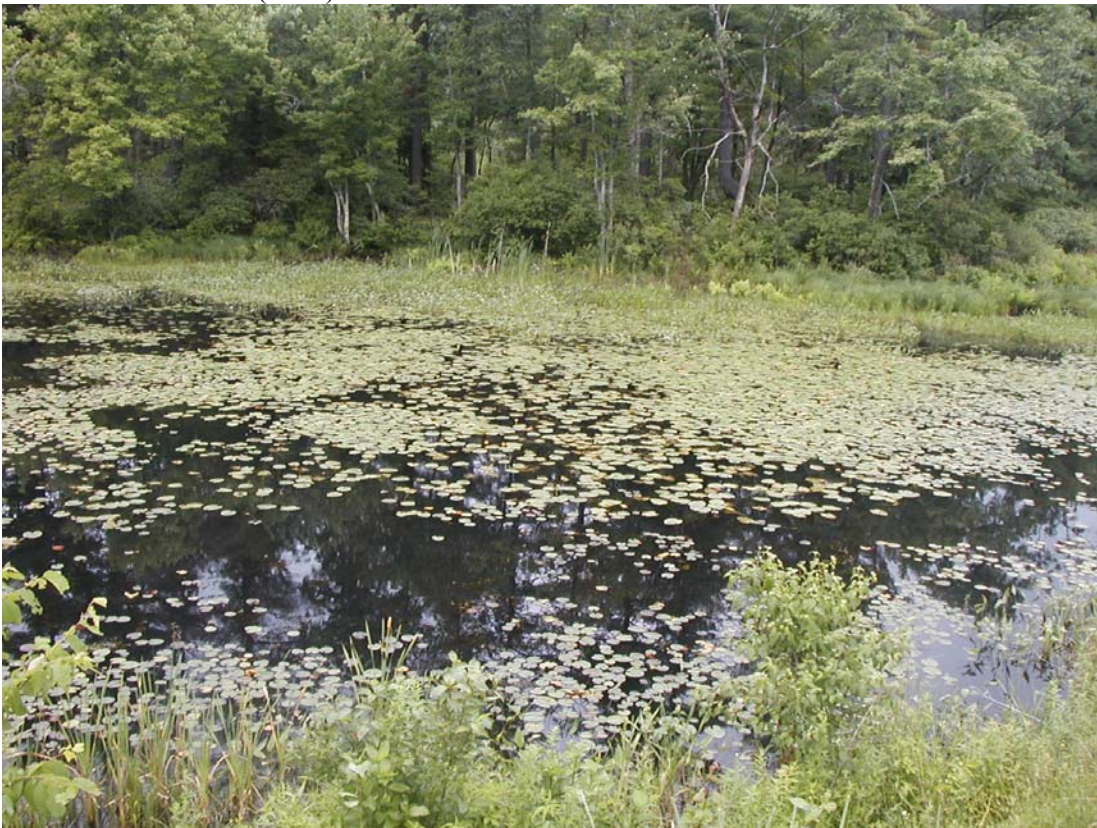
Photo No.: 10, Date: 6/25/04, Courtesy Smart Associates

Description: Wildlife species noted include Canada geese, Hooded mergansers, fish, frogs and turtles. Other species likely to use this area include muskrat, deer, wading birds and ducks, and other amphibians and reptiles.

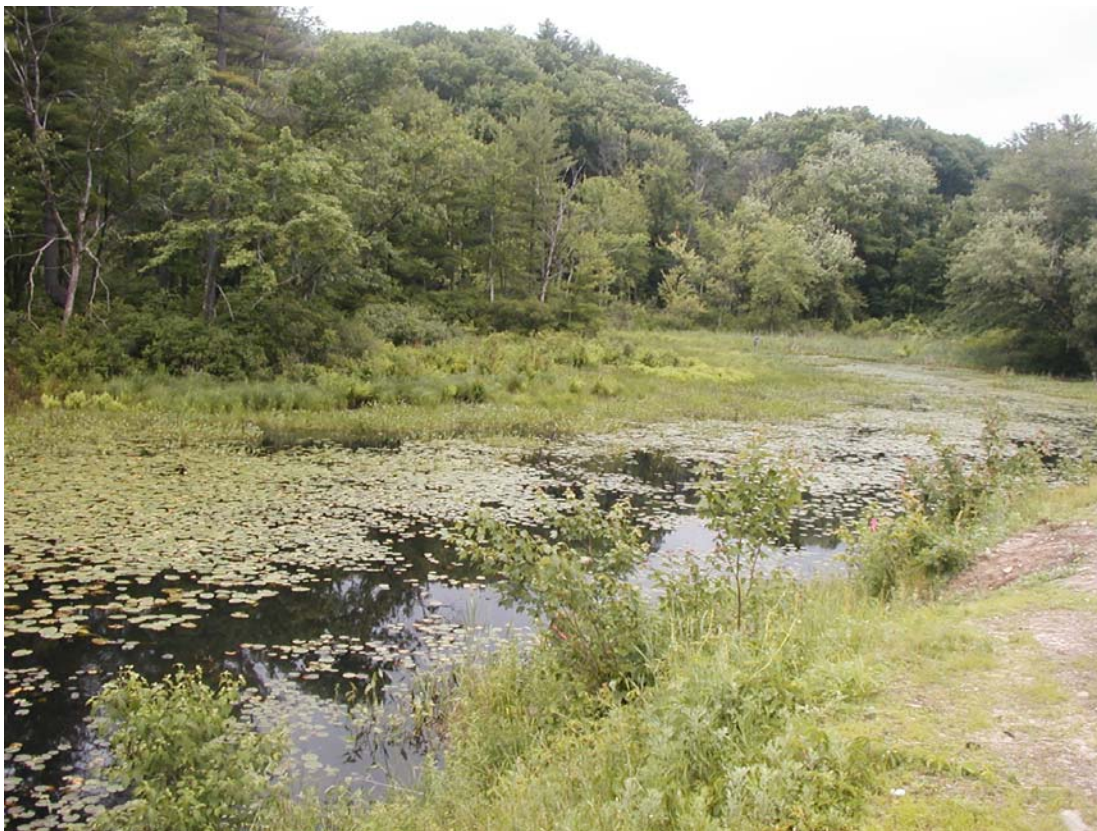
Photo No.: 11, Date: 6/25/04, Courtesy Smart Associates

Description: During most years it appears that this wetland becomes dominated by vegetation, with pockets of open water shrinking as the summer season passes.

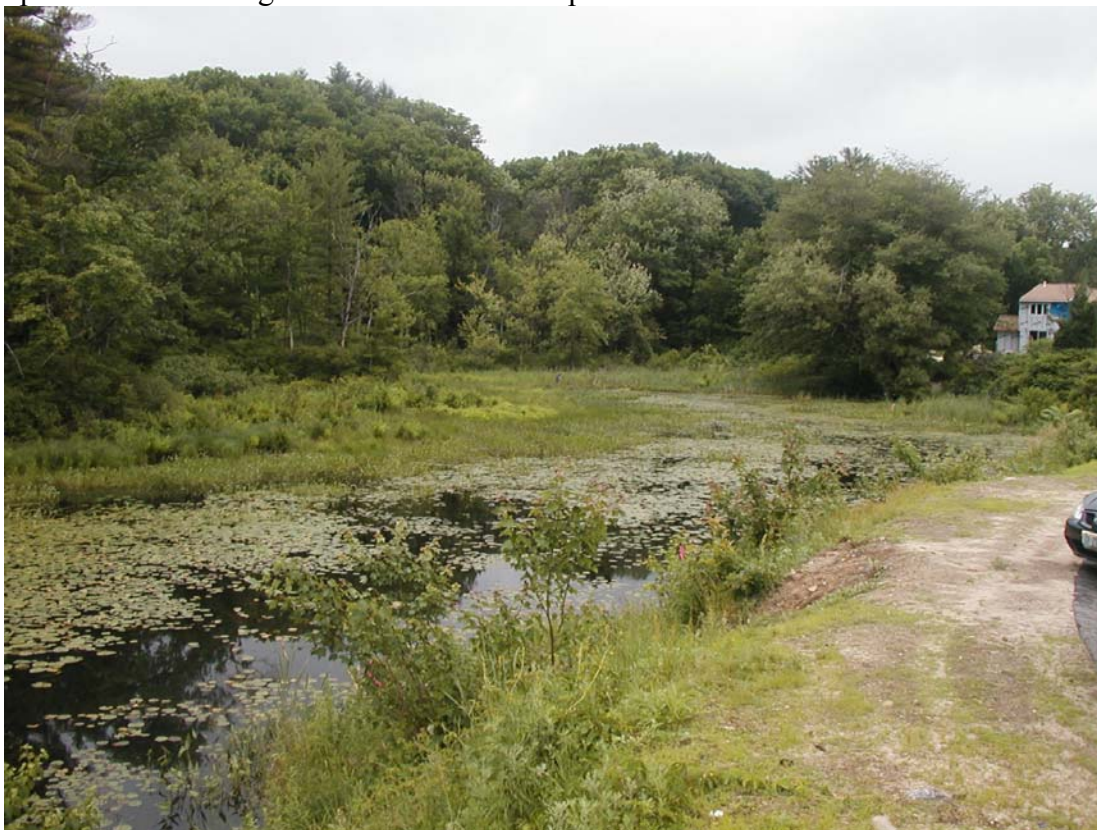
Photo No.: 12, Date: 6/25/04, Courtesy Smart Associates

Description: Some development has encroached on this wetland over the years.

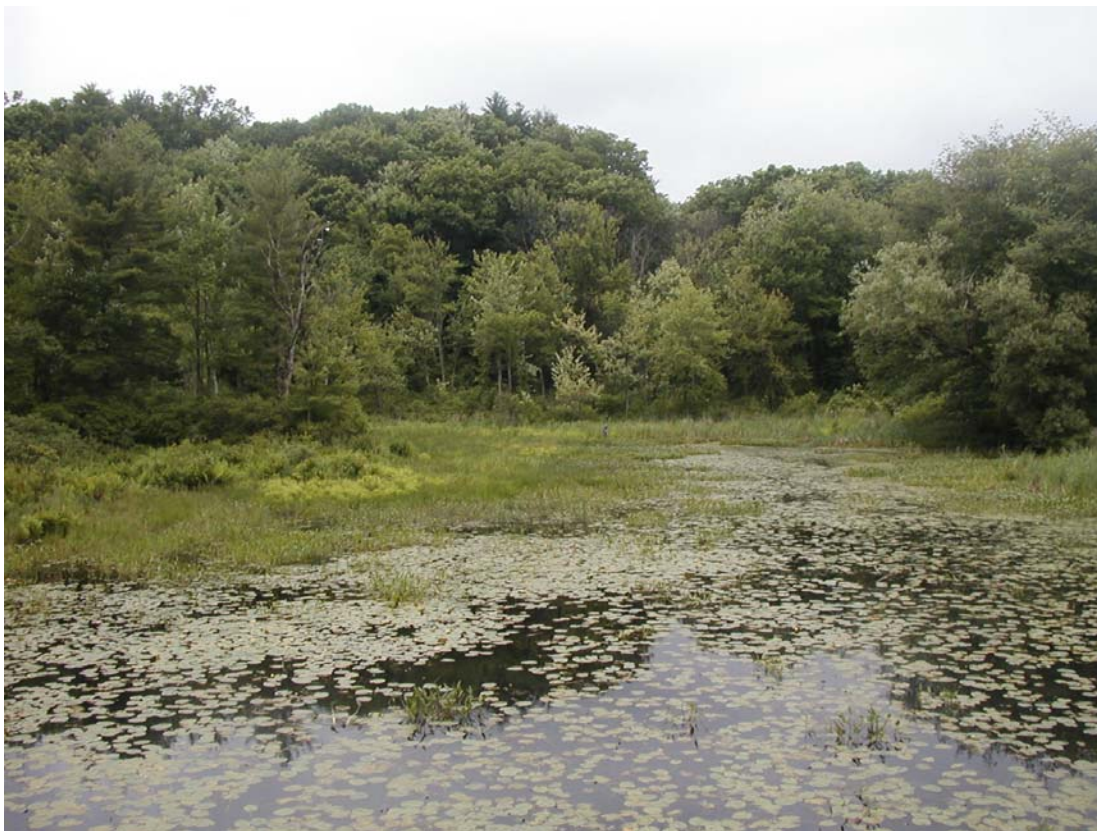
Photo No.: 13, Date: 6/25/04, Courtesy Smart Associates

Description: The small intermittent brook enters this wetland just to the right of center.

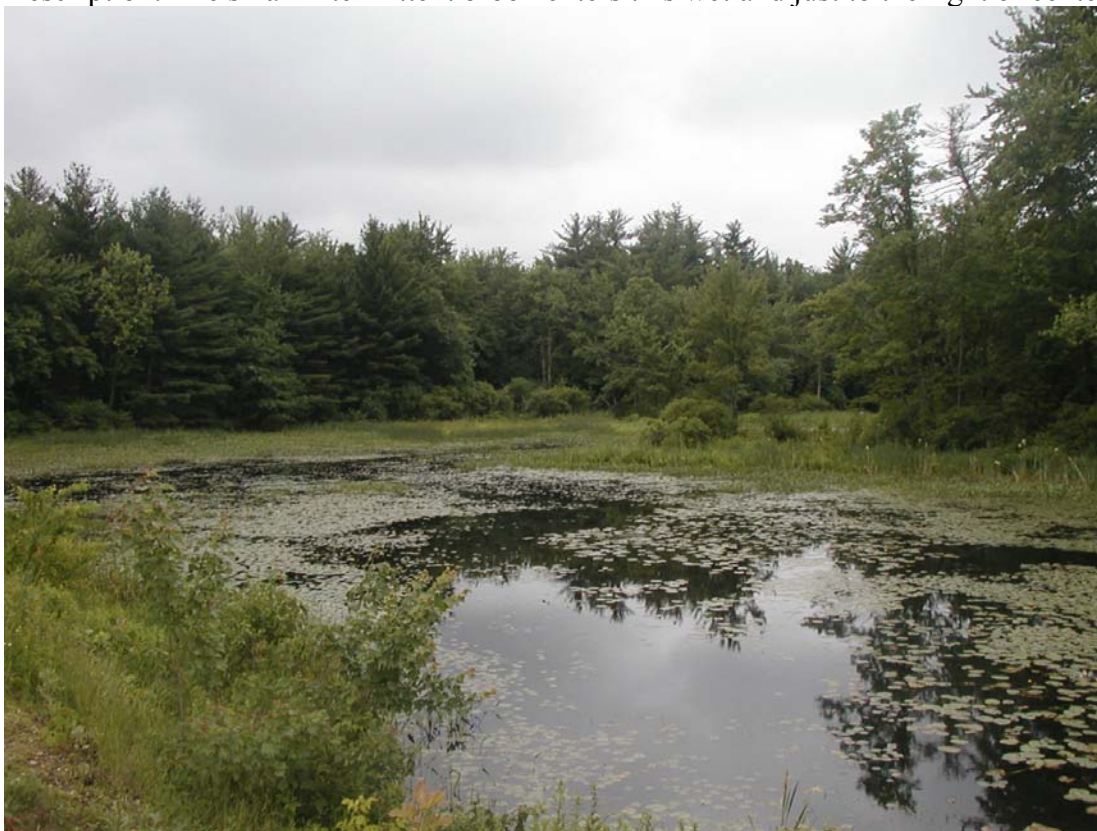
Photo No.: 14, Date: 6/25/04, Courtesy Smart Associates

Description: View of the POW wetland facing south.

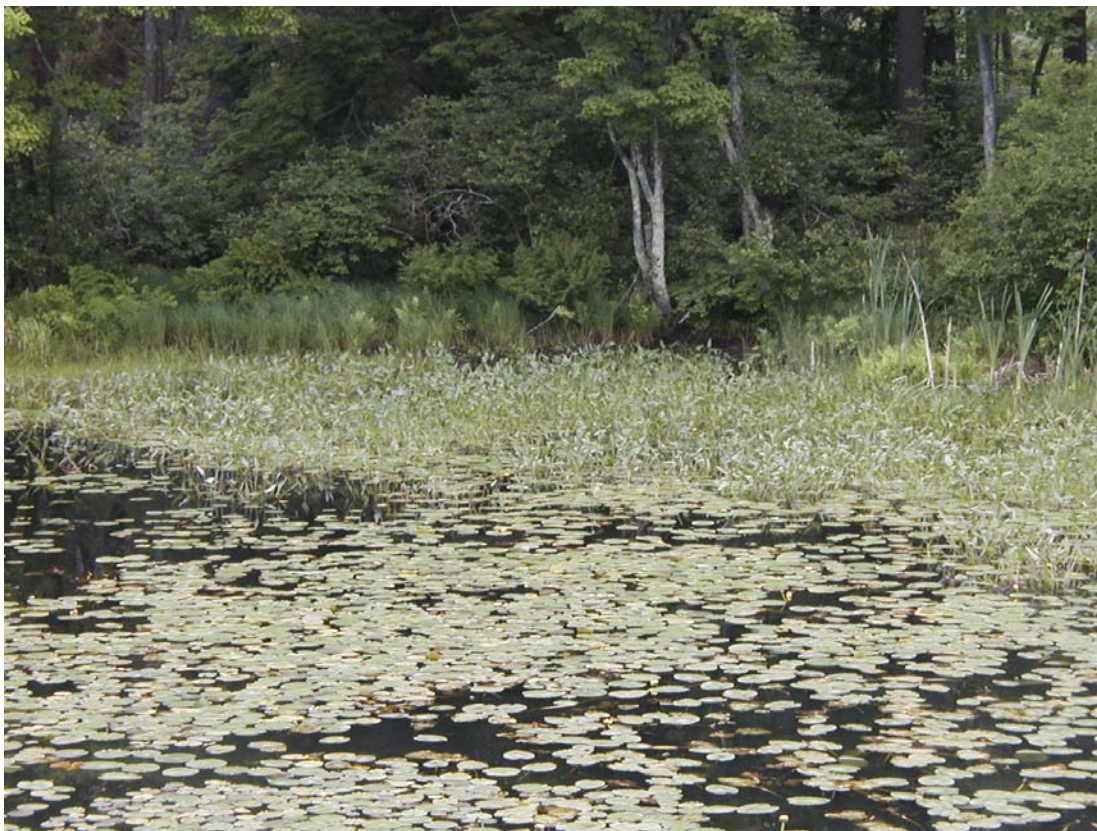
Photo No.: 15, Date: 6/25/04, Courtesy Smart Associates

Description: Several species of arrowhead (*Sagittaria sp.*) are found in this wetland.

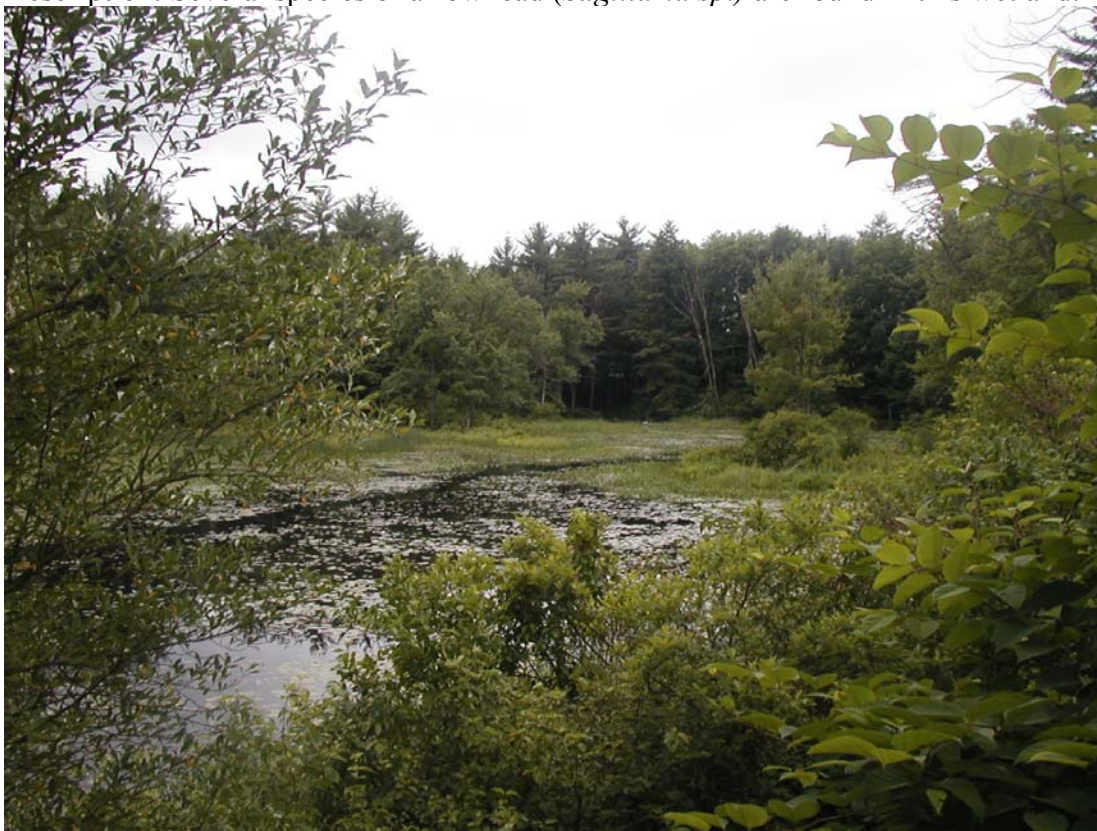
Photo No.: 16, Date: 6/25/04, Courtesy Smart Associates

Description: From this view it appears that the intermittent brook has developed a channel through the wetland.

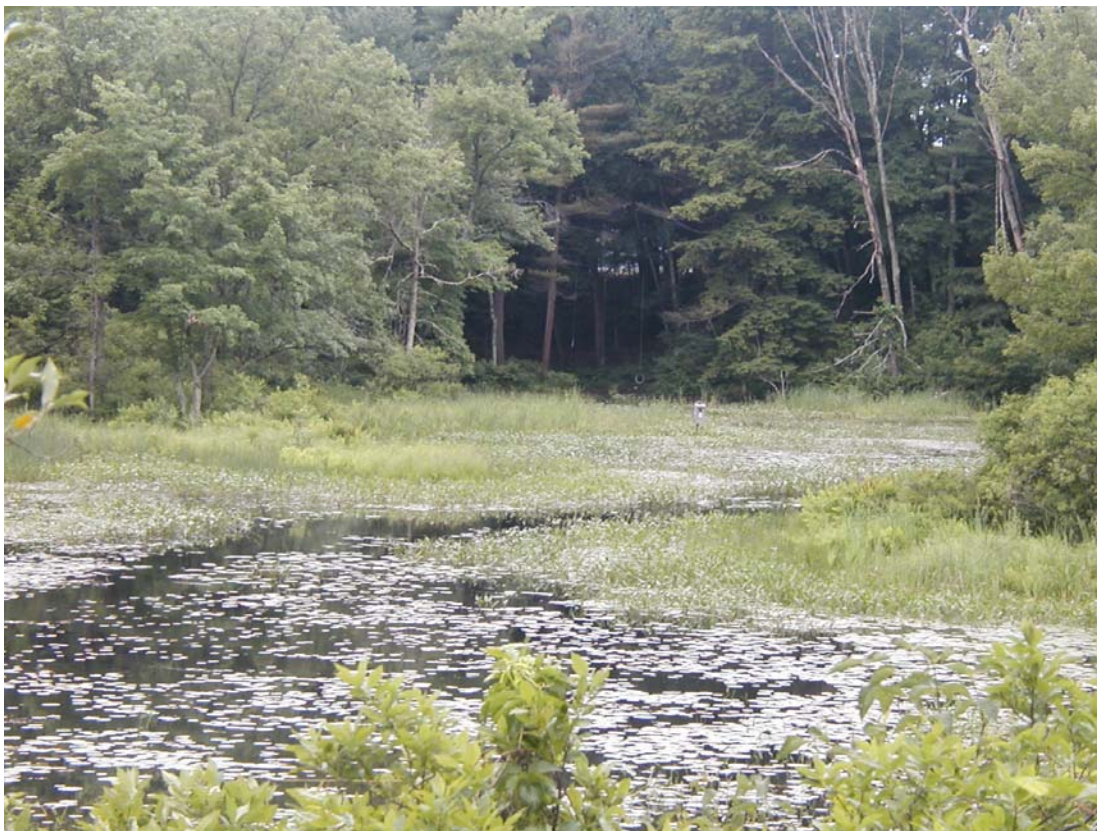
Photo No.: 17, Date: 6/25/04, Courtesy Smart Associates
Description: Close-up view of the intermittent brook confluence.

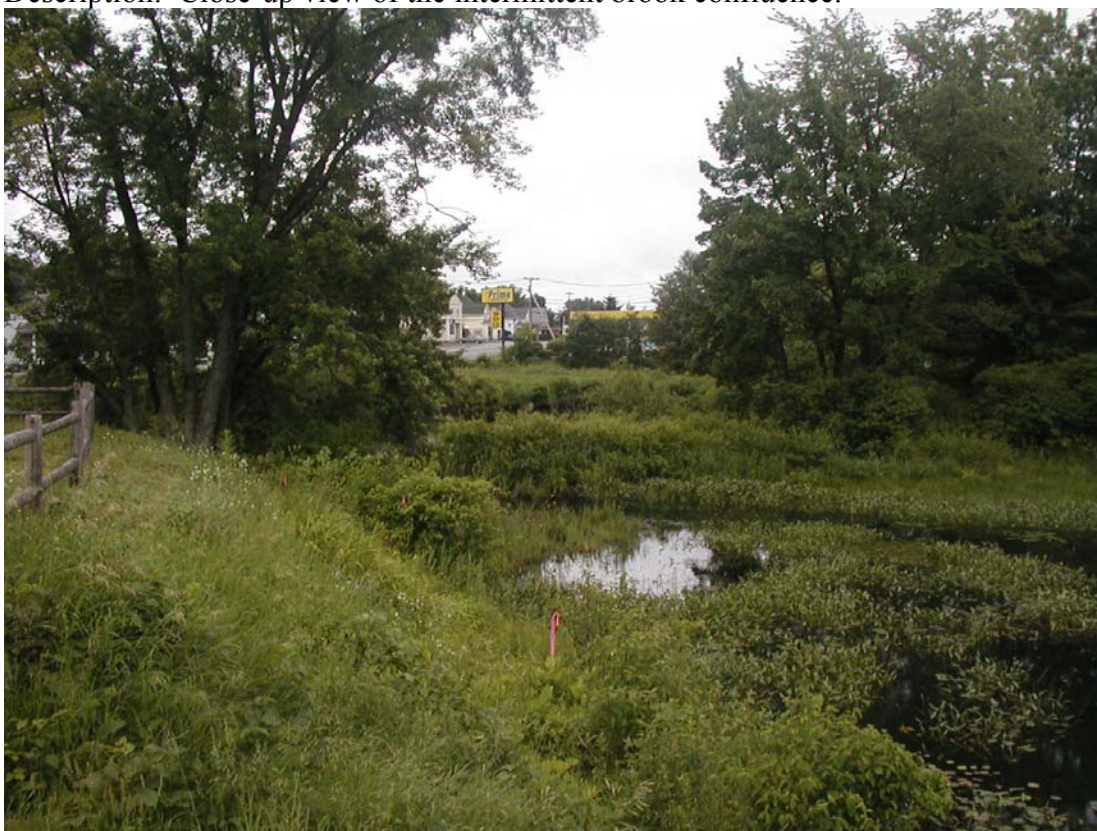
Photo No.: 18, Date: 6/25/04, Courtesy Smart Associates
Description: View of the confluence of the wetland with the river, facing southeast. The Merrimack Fire Station is to the left.

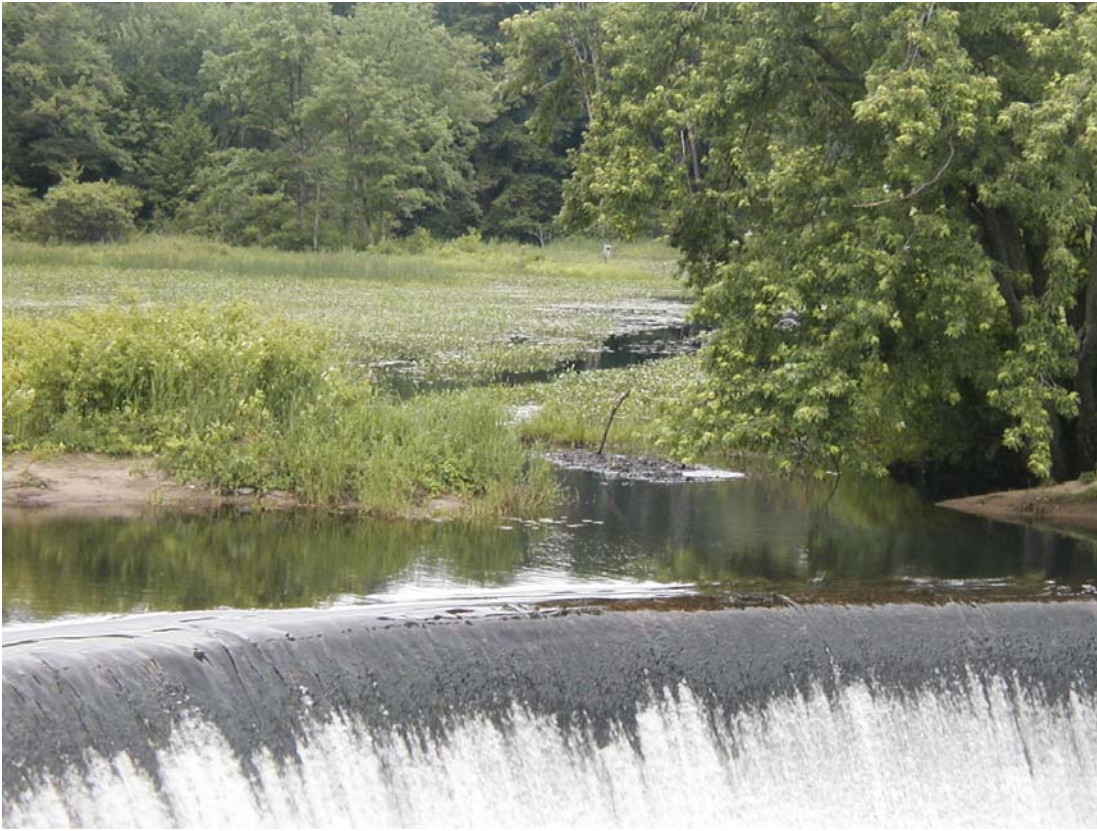
Photo No.: 19, Date: 6/25/04, Courtesy Smart Associates

Description: Close-up view of the dam and the confluence of the POW wetland.

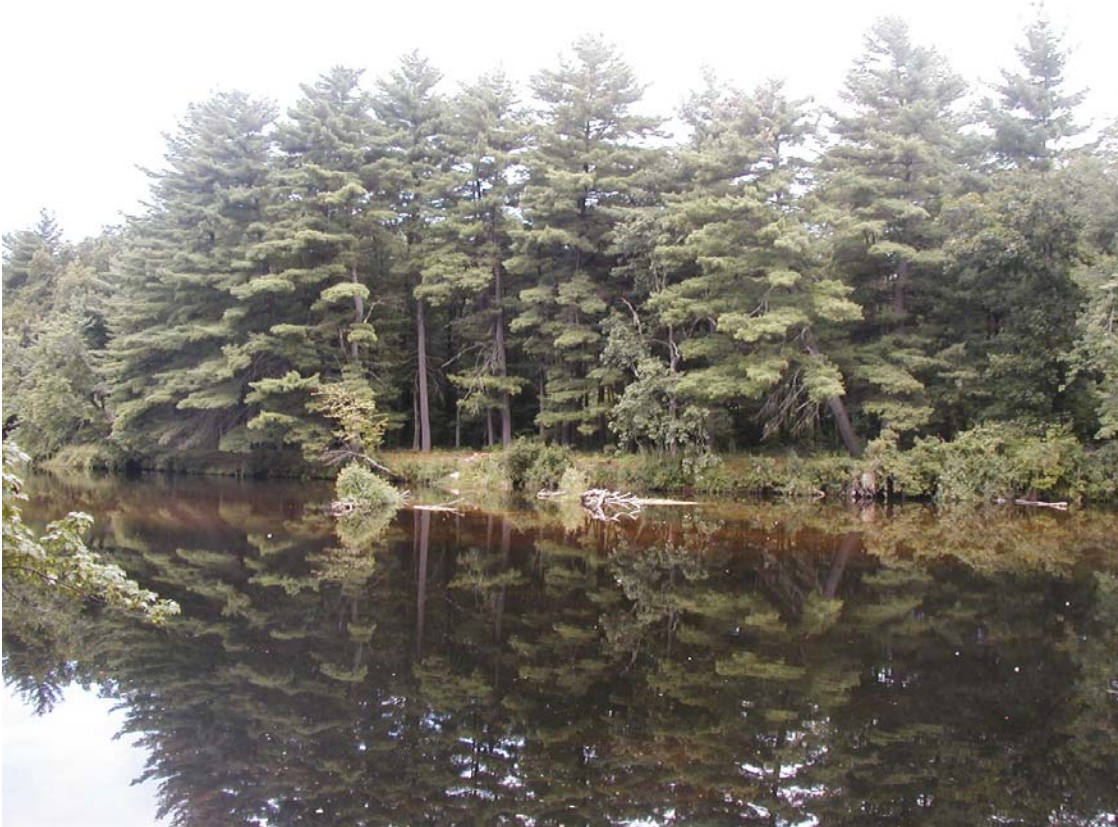
Photo No. 20, Date: 8/6/04, Courtesy Smart Associates

Description: Typical embankment upstream of the Merrimack Village Dam.

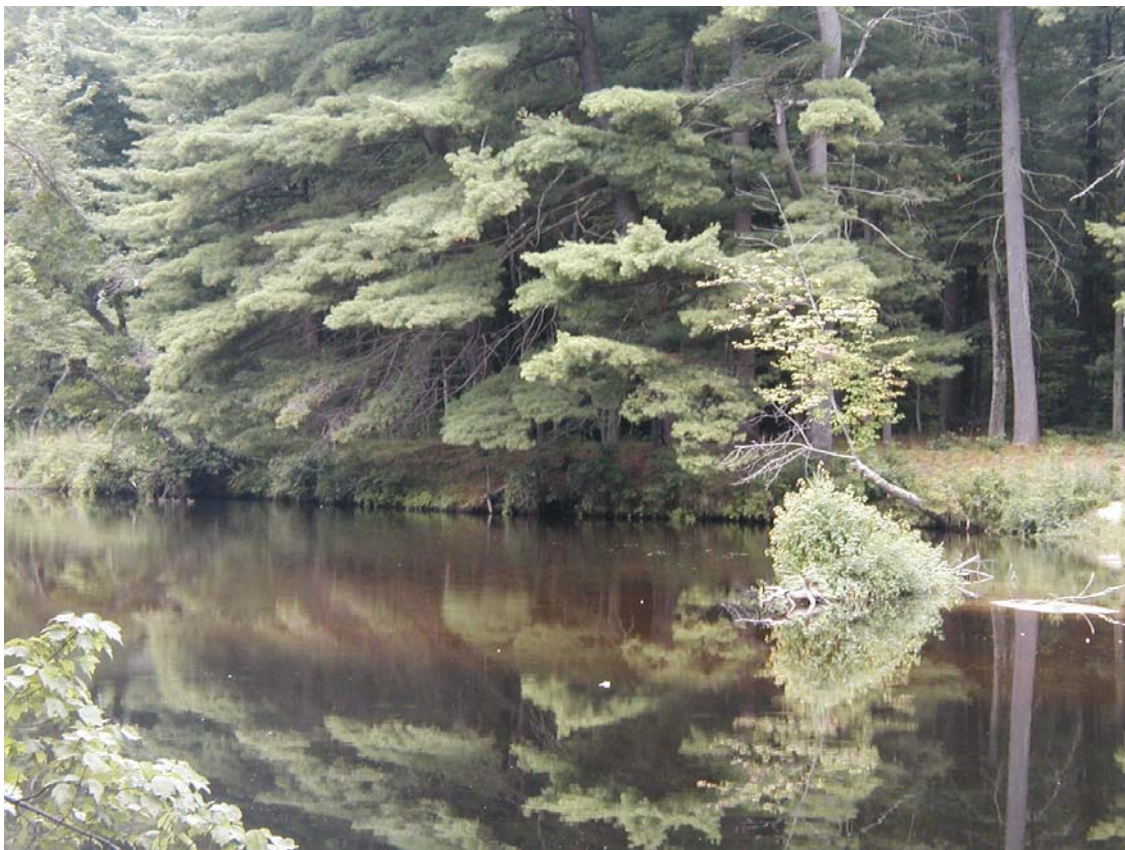
Photo No. 21, Date: 8/6/04, Courtesy Smart Associates
Description: Close-up of typical embankment upstream of the MVD.

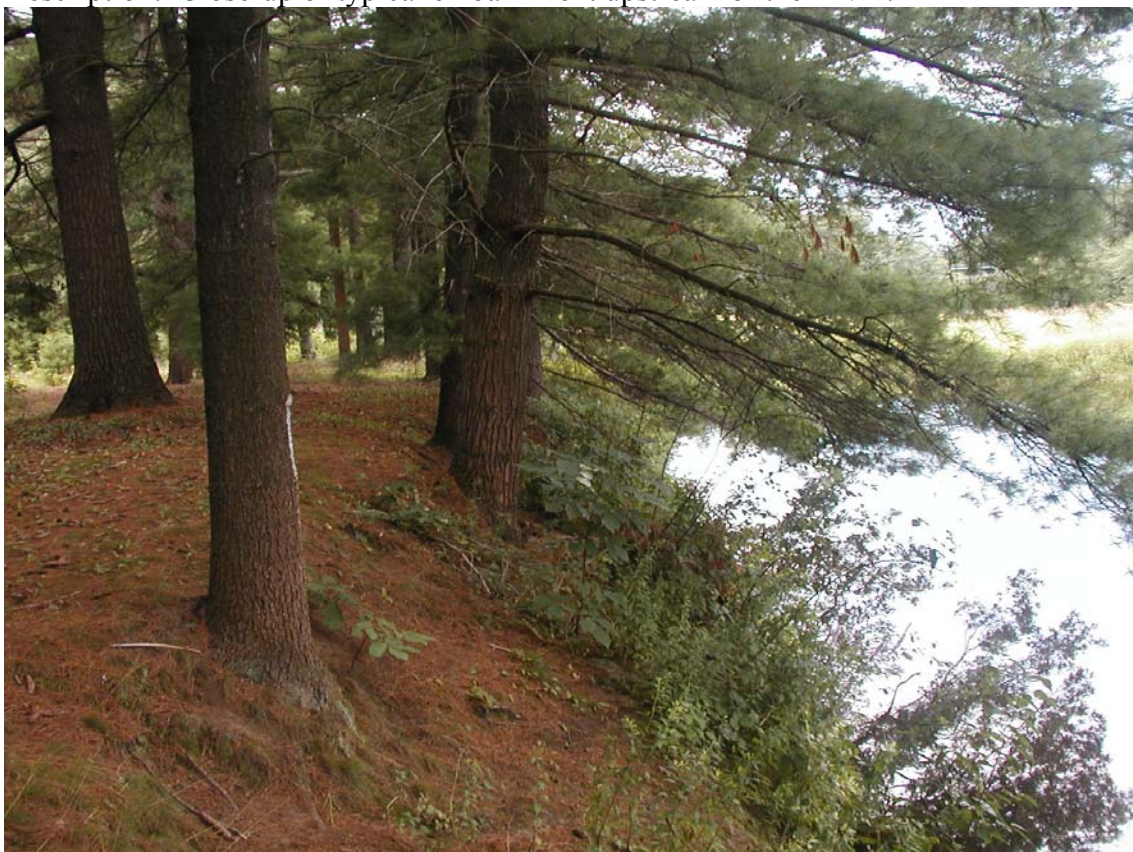
Photo No. 22, Date: 8/6/04, Courtesy Smart Associates
Description: Large white pines growing along the embankment.

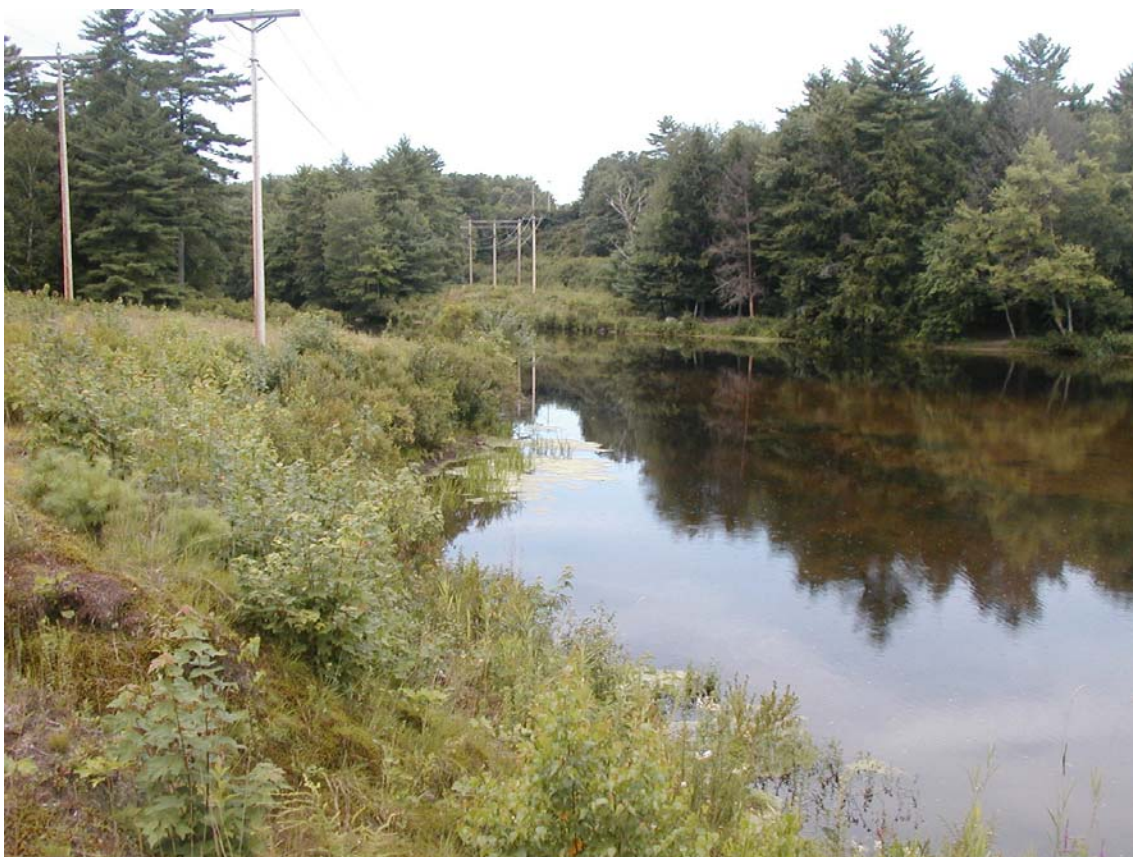
Photo No. 23, Date: 8/6/04, Courtesy Smart Associates

Description: Scattered wetland plants found along the edges of the river in some locations

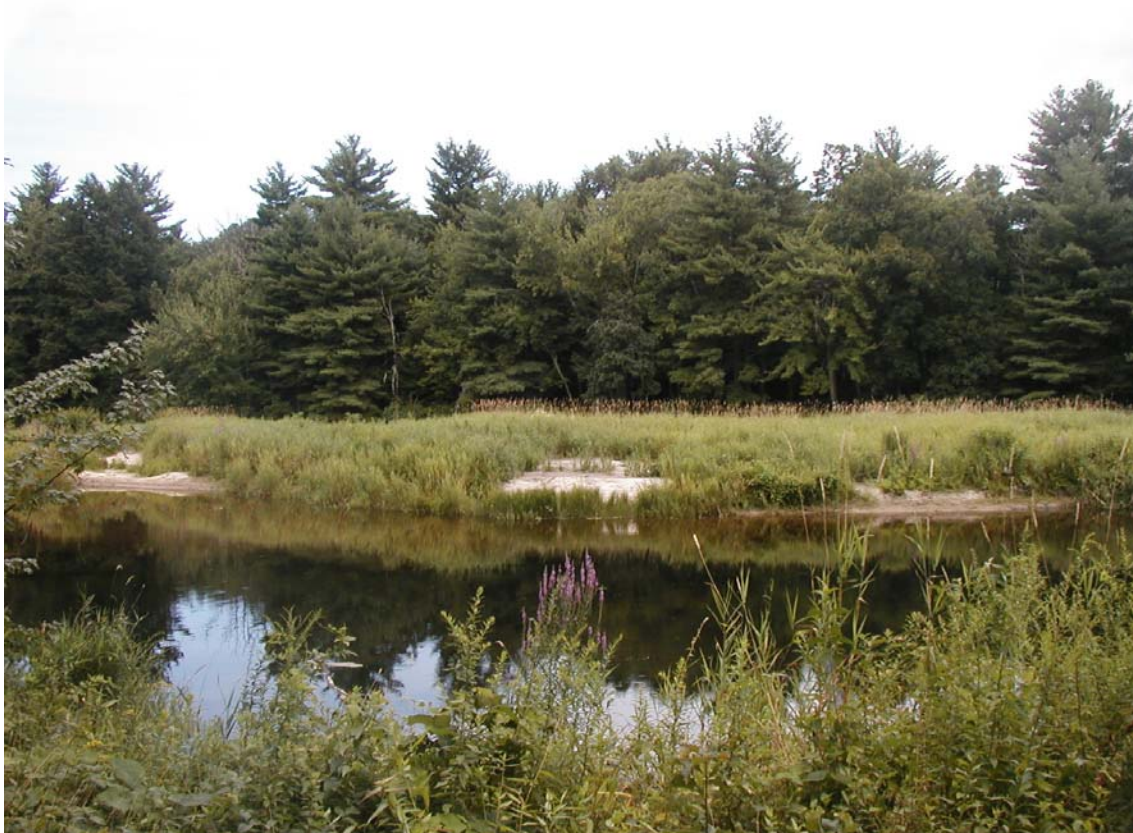
Photo No. 24, Date: 8/6/04, Courtesy Smart Associates

Description: Island in the middle of the river, created by deposits of sand.
